AV3500 Series Facemask

PRODUCT NOTICE

Date: February 2016

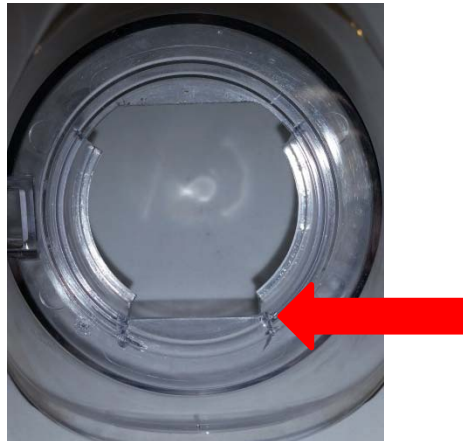
It has come to the attention of Biomarine that a small number of fielded AV3500 Series Facemask Assemblies have suffered cracking and/or breakage in the location of the BioPak 240R facepiece lens interface connection. This issue requires prompt inspection and correction to avoid possible injury to any BioPak 240R user caused by the sudden disconnection of the BioPak from the facemask.

Biomarine has determined the cause of the cracking to be a concentration of stress in sharp molded corners of the raw mask front opening as depicted below. The sharp corners serve to concentrate stress and promote possible cracking in the mask.

Biomarine has no control over the formation of the sharp corners in the mask as it is a third party supplied component; however, Biomarine can provide a remedy to the cracking issue. Biomarine will remove the front adapter pieces of the mask and remove the silicone gasket material from the front adapter piece. A solid polycarbonate gasket will be solvent-welded directly to the raw mask and the front adapter will be solvent welded directly to the solid polycarbonate gasket creating a gas-tight seal of the adapter to the mask.

The remedy will increase the bearing surface of the raw mask to external forces by a factor of sixteen (16) times. This will equate to an increase of force resistance of 6.5. In the current design a 1-pound force applied to the top or bottom of the plug-in hose adapter would impart a 2.5-pound force on the raw mask bearing surface. With the remedied design it would take a minimum force of 16.3-pounds applied to the top or bottom of the plug-in hose adapter to impart the same stresses on the raw mask.

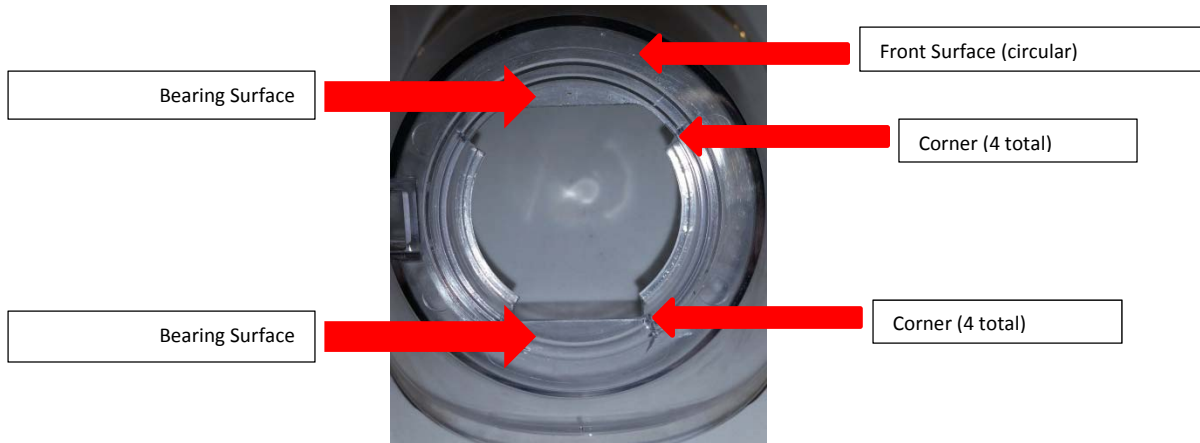
4. Inspect the front mask surface, bearing surface and corners as depicted below for cracks or breakage.

The damage that is occurring is a long-term effect of the mask design. If masks are not seen to be cracking it is not expected that sudden breakage of the mask will occur and continued use of the mask is safe. It is still advised to have the modification completed on masks with no cracking detected to prevent possible cracking in the future.

Contact the Biomarine Service Manager, Jack Derfler, as directed below for assistance in scheduling a Biomarine field visit or for returning masks to Biomarine. **DO NOT RETURN ANY MASKS TO BIOMARINE WITHOUT FIRST CONTACTING THE BIOMARINE SERVICE MANAGER.**
